**Village Lake Stream
Final Construction Report
May 2012**

VILLAGE LAKE STREAM RESTORATION PROJECT FINAL REPORT NOBLE COUNTY, INDIANA

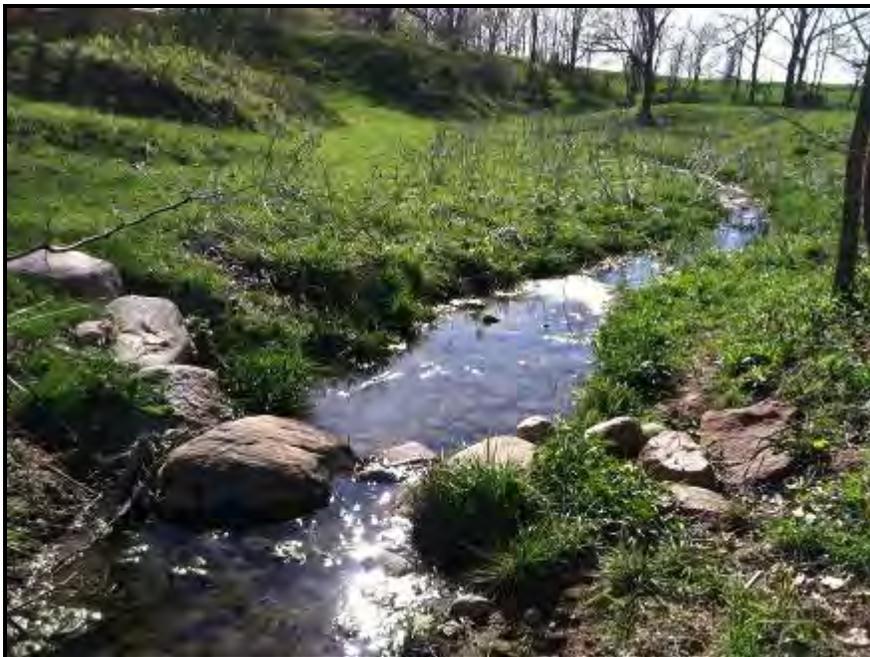
Figure 4. Typical grade control installed in Village Lake stream to prevent stream incision.

To protect the stream from future incision, the grade of the entire stream was controlled with rock drop structures know as grade controls. There were 27 control structures built into the stream averaging one every 50 feet in the upper section where grades were as steep as 3 percent and 1 every 100 feet or more where grades were less than 1 percent toward the bottom. These grade controls are constructed by excavating a trench across the channel and into the floodplain at least three feet and then filling this trench with boulders from 12 to 36 inches. The more successful structures had a shallow “U” shape with the most upstream rock being the center rock. The greatest fall in these structures was two feet, requiring flat rocks at the point of fall on the downstream end to prevent scour. Since rocks are not consistent in size and shape, some structures worked better than others, and repairs had to be made to at least a third of the structures to prevent the channel from migrating around the structure. Figure 3 shows a typical structure that worked well.

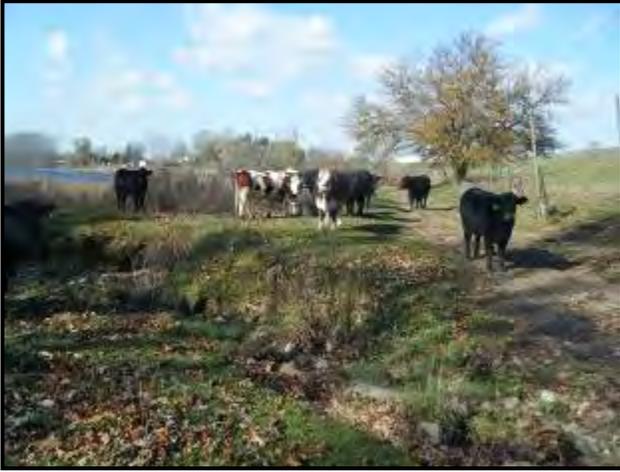
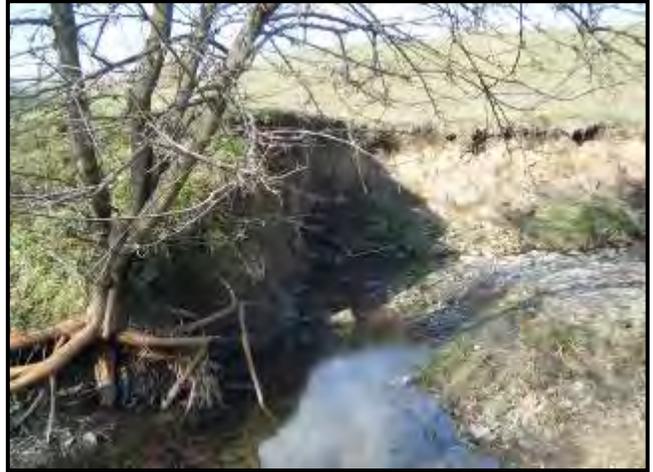
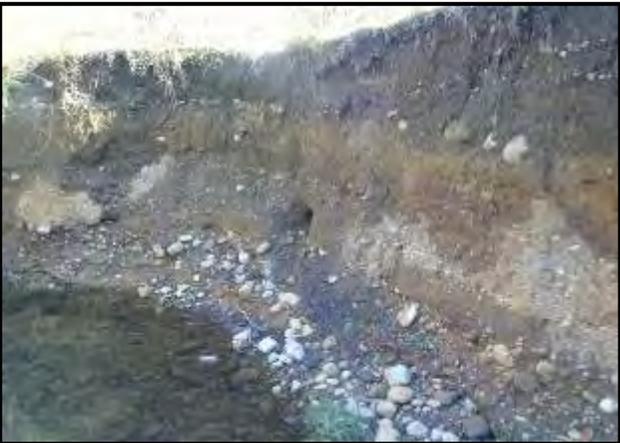
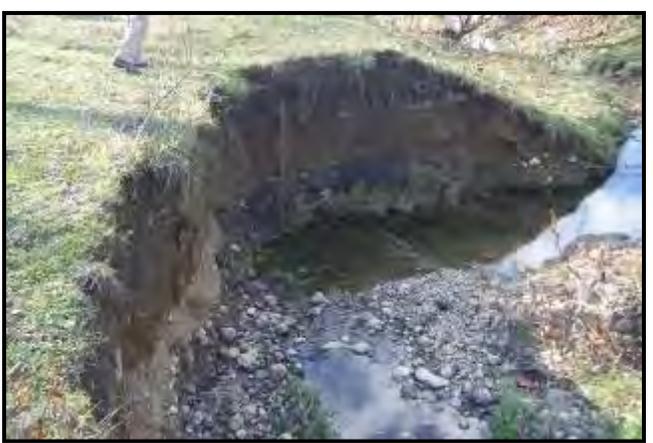
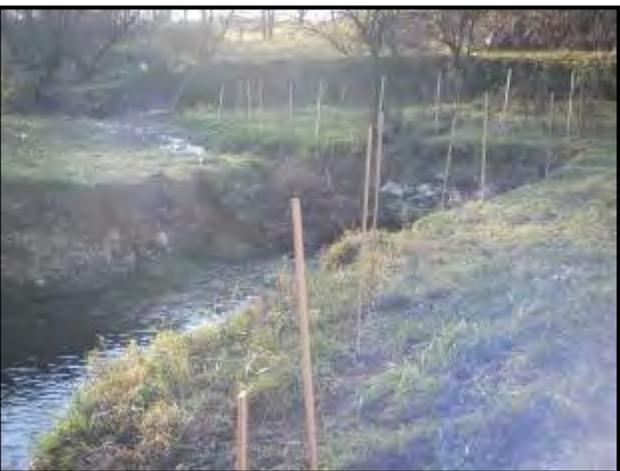
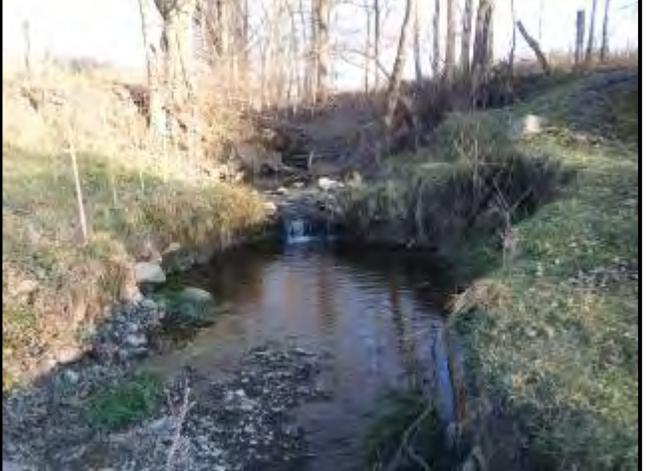
Pre-Construction Photographs

The stream channel was a series of scoured reaches (clay bottom), avulsed reaches (piled up gravel and cobble), and shifting sand and fine gravel bed (toward the lake).

The centerline of the channel meandered in its available floodprone area, bouncing from one high bank to another, creating vertical embankments. Cattle grazed freely on slopes ranging from 30 degree angles to near vertical embankments where grass was available. A great deal of cattle waste was present in and adjacent to the channel. Riparian vegetation ranged from the well-grazed pasture grasses to multiflora rose, mulberry, box elder, and a large willow at the upper end, to oaks, cottonwood, Kentucky coffee tree, and honeysuckle dominated system in the middle reach, to more open grazed pasture grasses and scattered oaks at Village Lake (V3 Companies, Ltd., 2009) complete report for additional soil descriptors and a wetland delineation of the parcel.
